Coconut Grove Playhouse Historic Report

Jorge L Hernandez Preservation Architect For Arquitectonica International 04.04.17

History of the Coconut Grove Playhouse

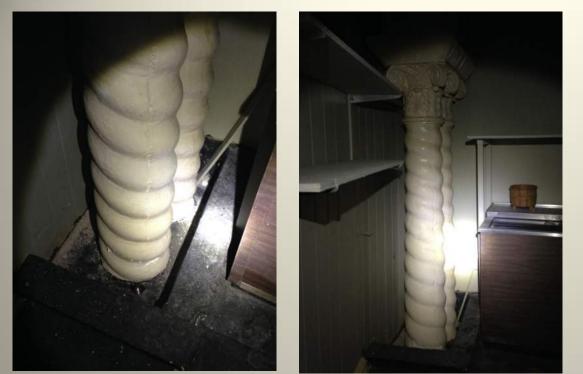
Solomonic Columns at the Concession Area that have been buried by

Alfred Browning Parkers change to the floor slope

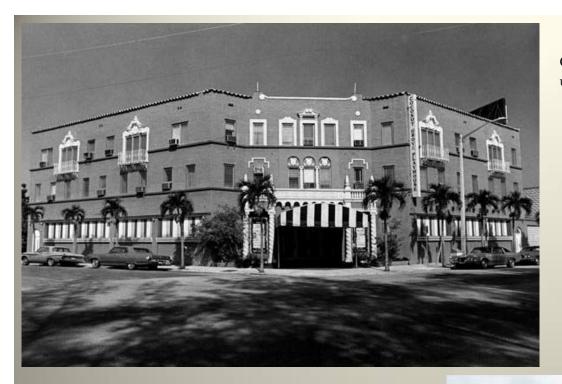
Coconut Grove Playhouse front elevation showing the closed up store fronts (Photo 1971)

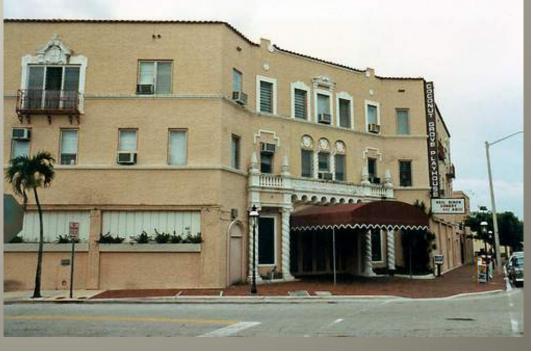
Coconut Grove Playhouse front elevation showing the elevated planters (Photo 1984)

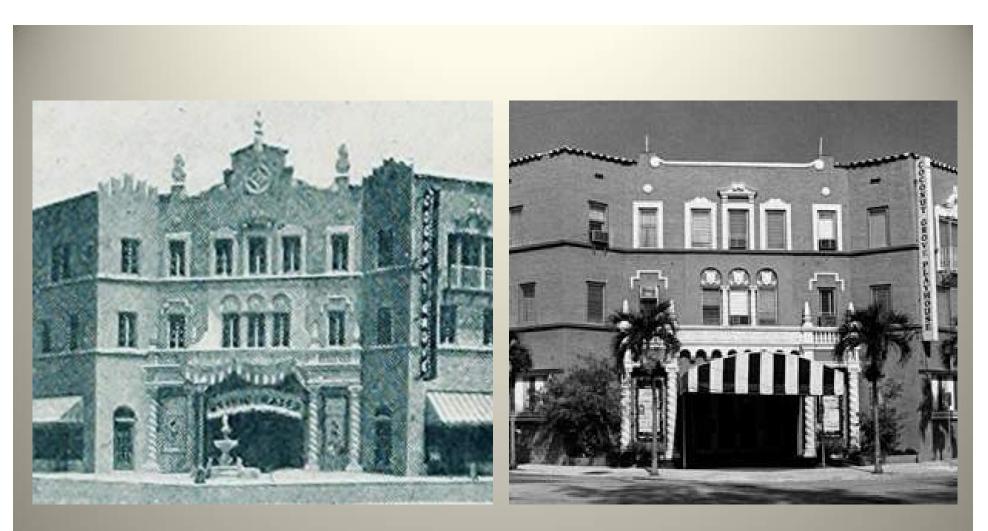
Comparison of the 1926 and 1971 Coconut Grove Playhouse front elevations showing the removal of the crenellation along the roof line.

Comparison of the 1926 and 1971 Coconut Grove Playhouse front elevations showing the removal of the crenellation along the roof line.
